BLUE LAKE LEVEE GEOTECHNICAL EVALUATION PROJECT CITY OF BLUE LAKE & HUMBOLDT COUNTY, CALIFORNIA

Prepared for:
HUMBOLDT COUNTY,
PUBLIC WORKS DEPARTMENT
&
CITY OF BLUE LAKE

Prepared by:
Fugro Consultants, Inc.
660 Clarion Court, Suite A
San Luis Obispo, CA 93401
&
CGI Technical Services, Inc.
1612 Wedding Way
Redding, CA 96003

Subject: Geotechnical Report, Blue Lake Levee Geotechnical Evaluation Project, City of
Blue Lake and Humboldt County, California

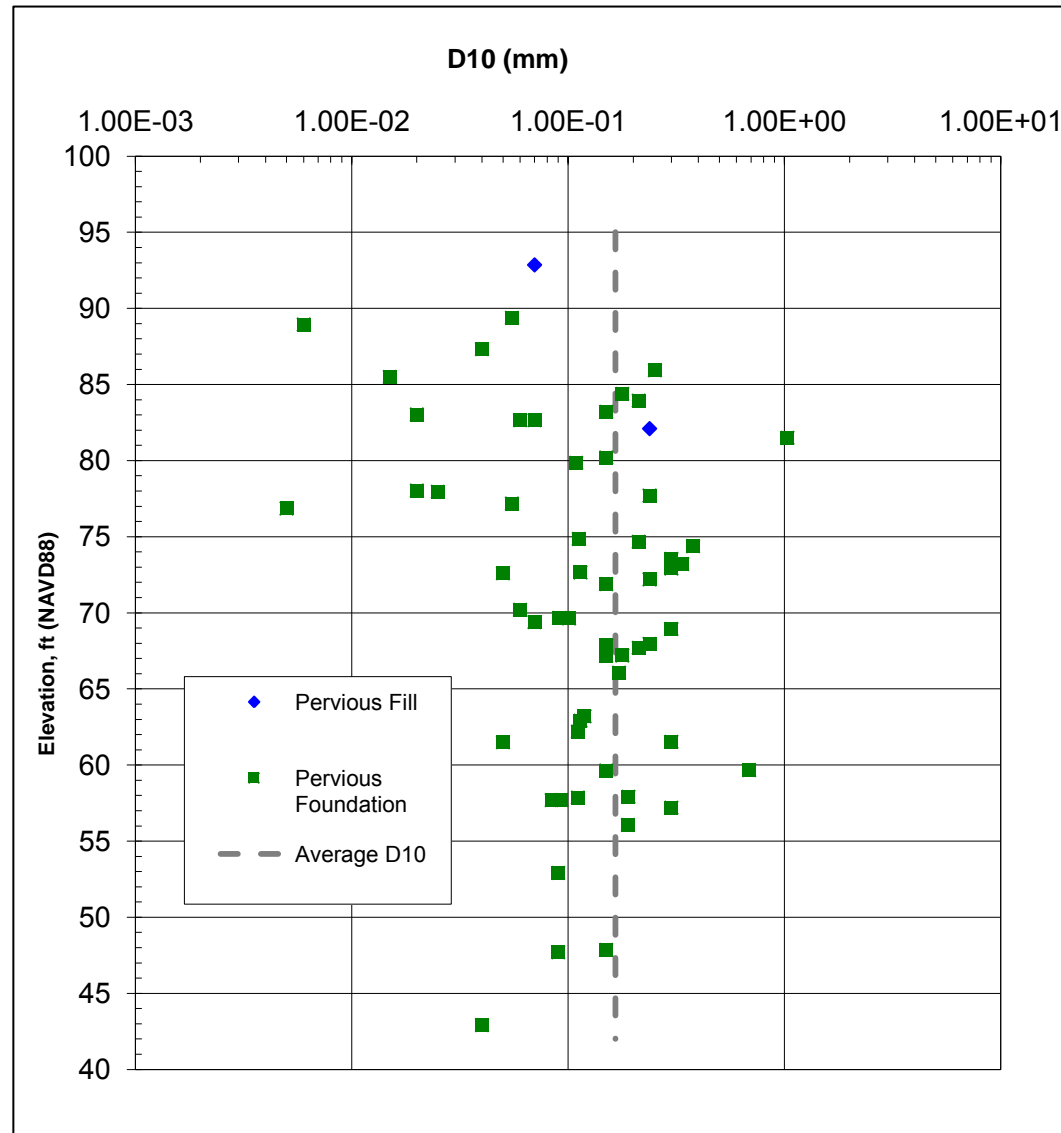
D₁₀ versus Elevation for Pervious Material

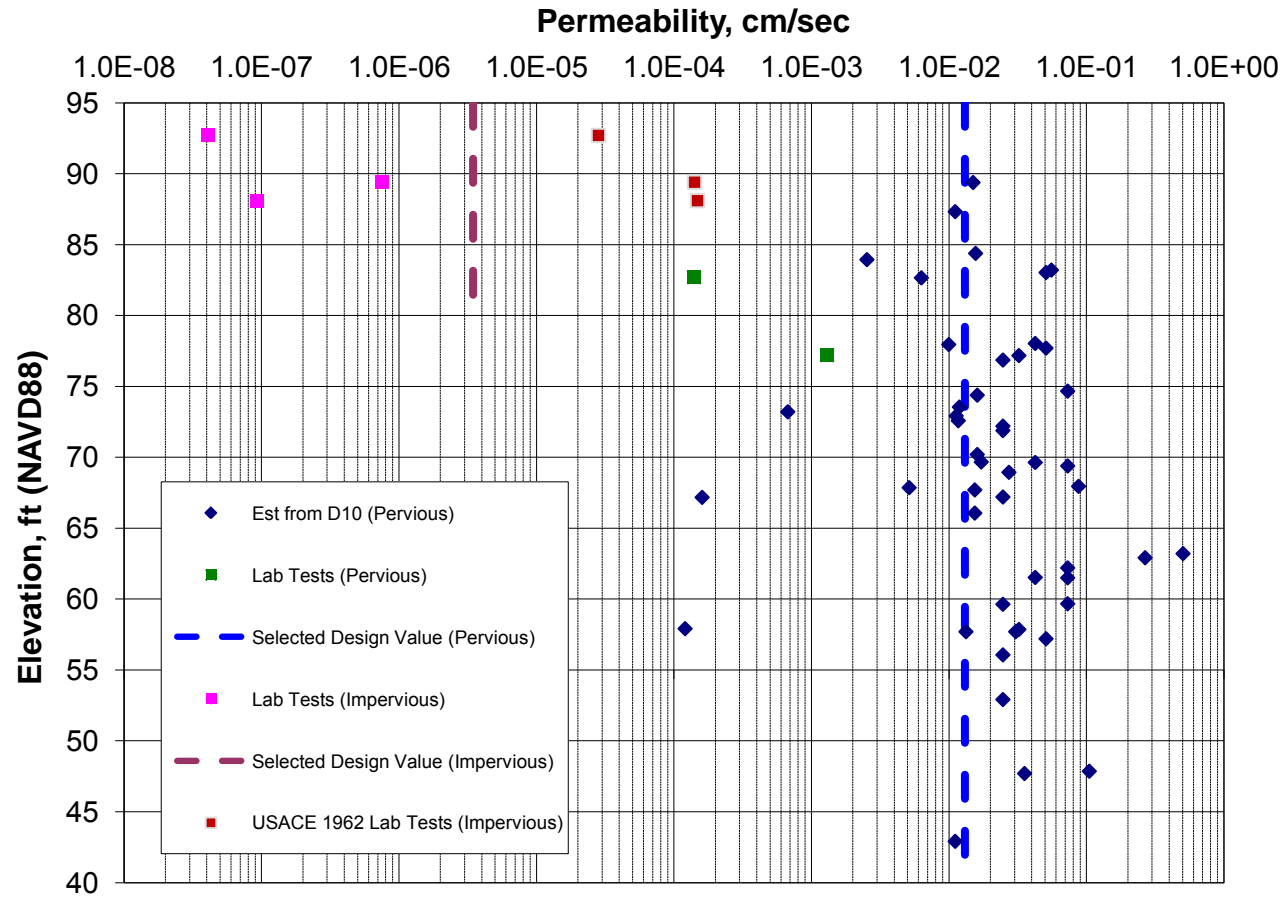
Estimated Foundation Permeability versus Elevation

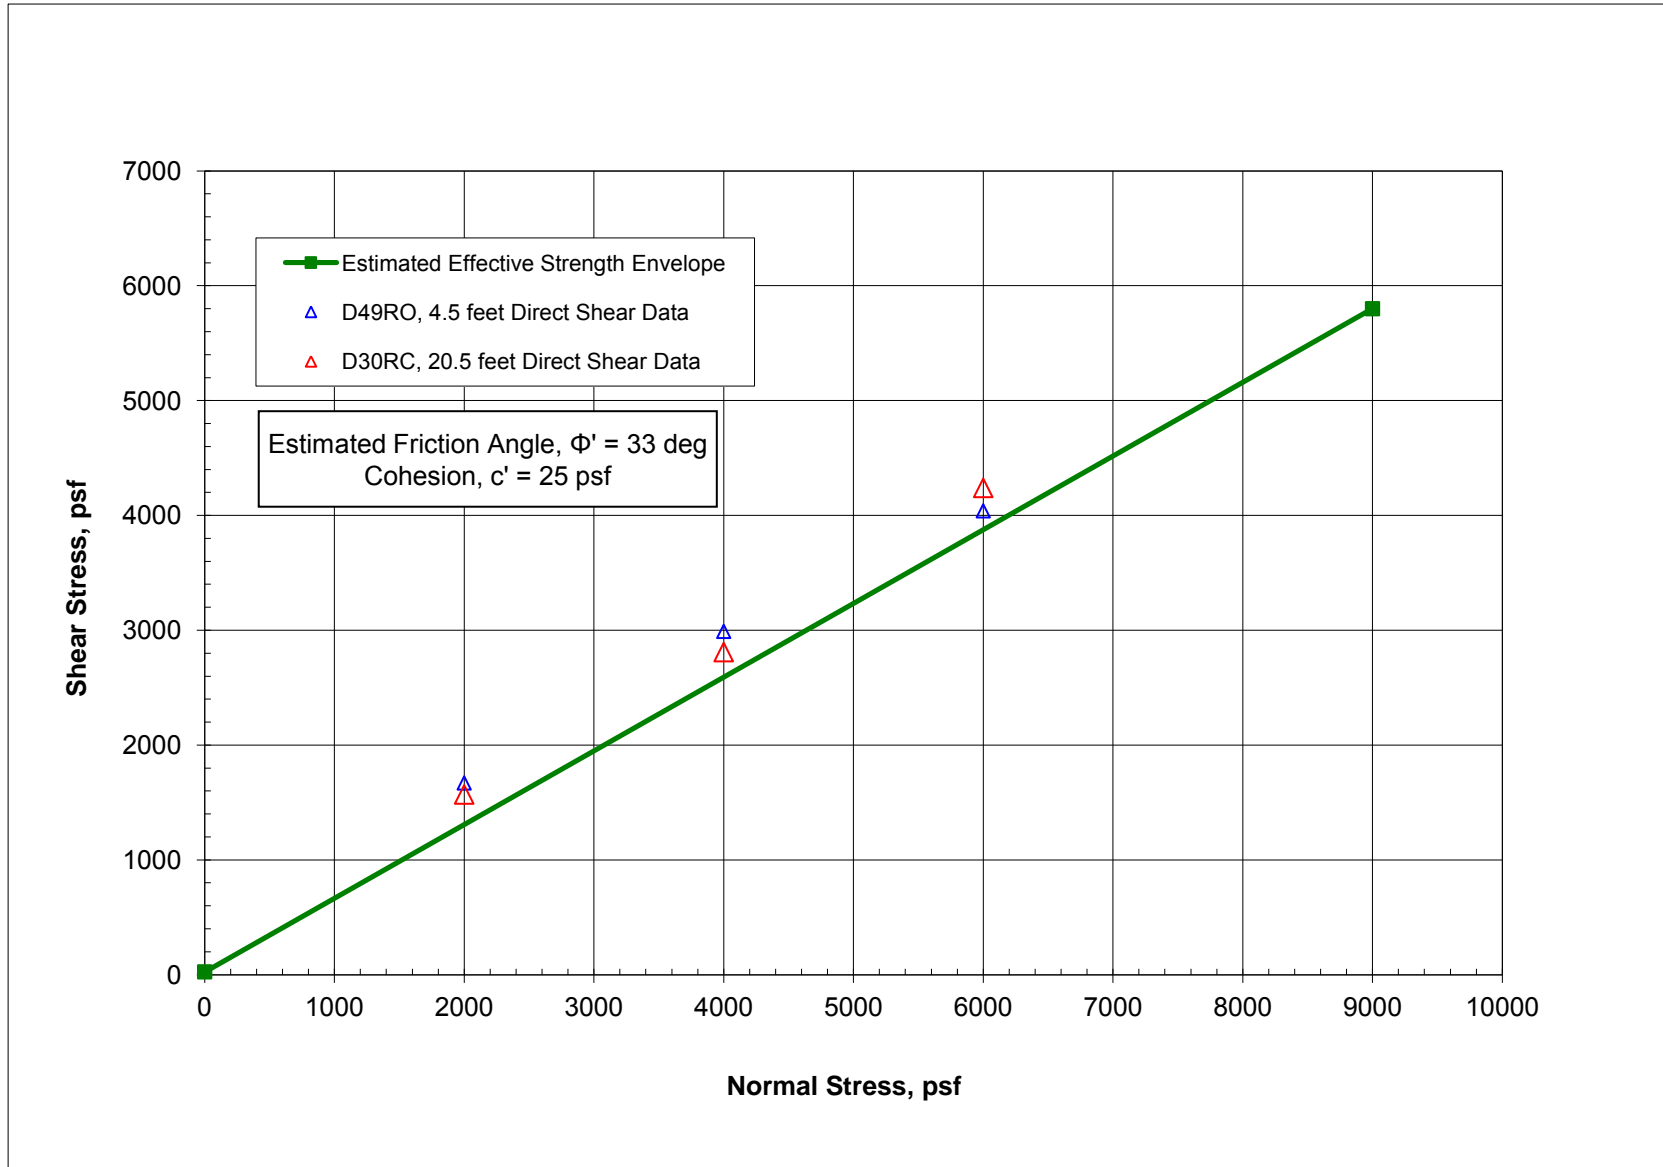
Effective Shear Strength Plot for Pervious Fill and Foundation Material

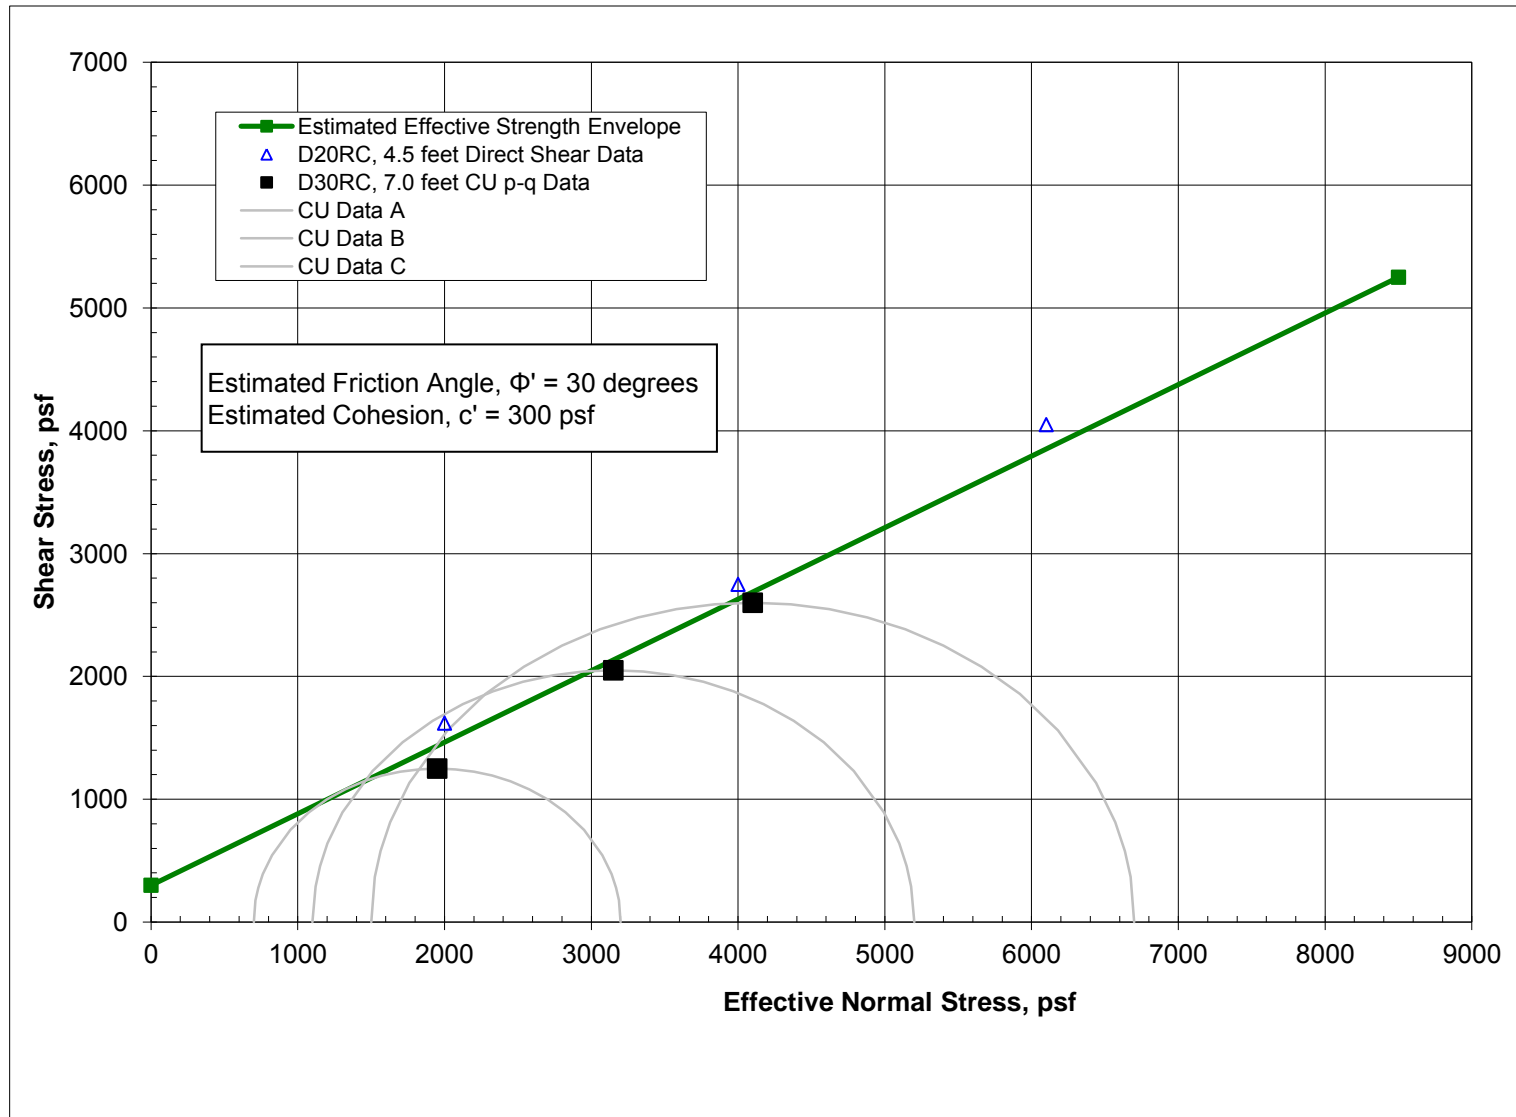
Effective Shear Strength Plot for Impervious Fill Material

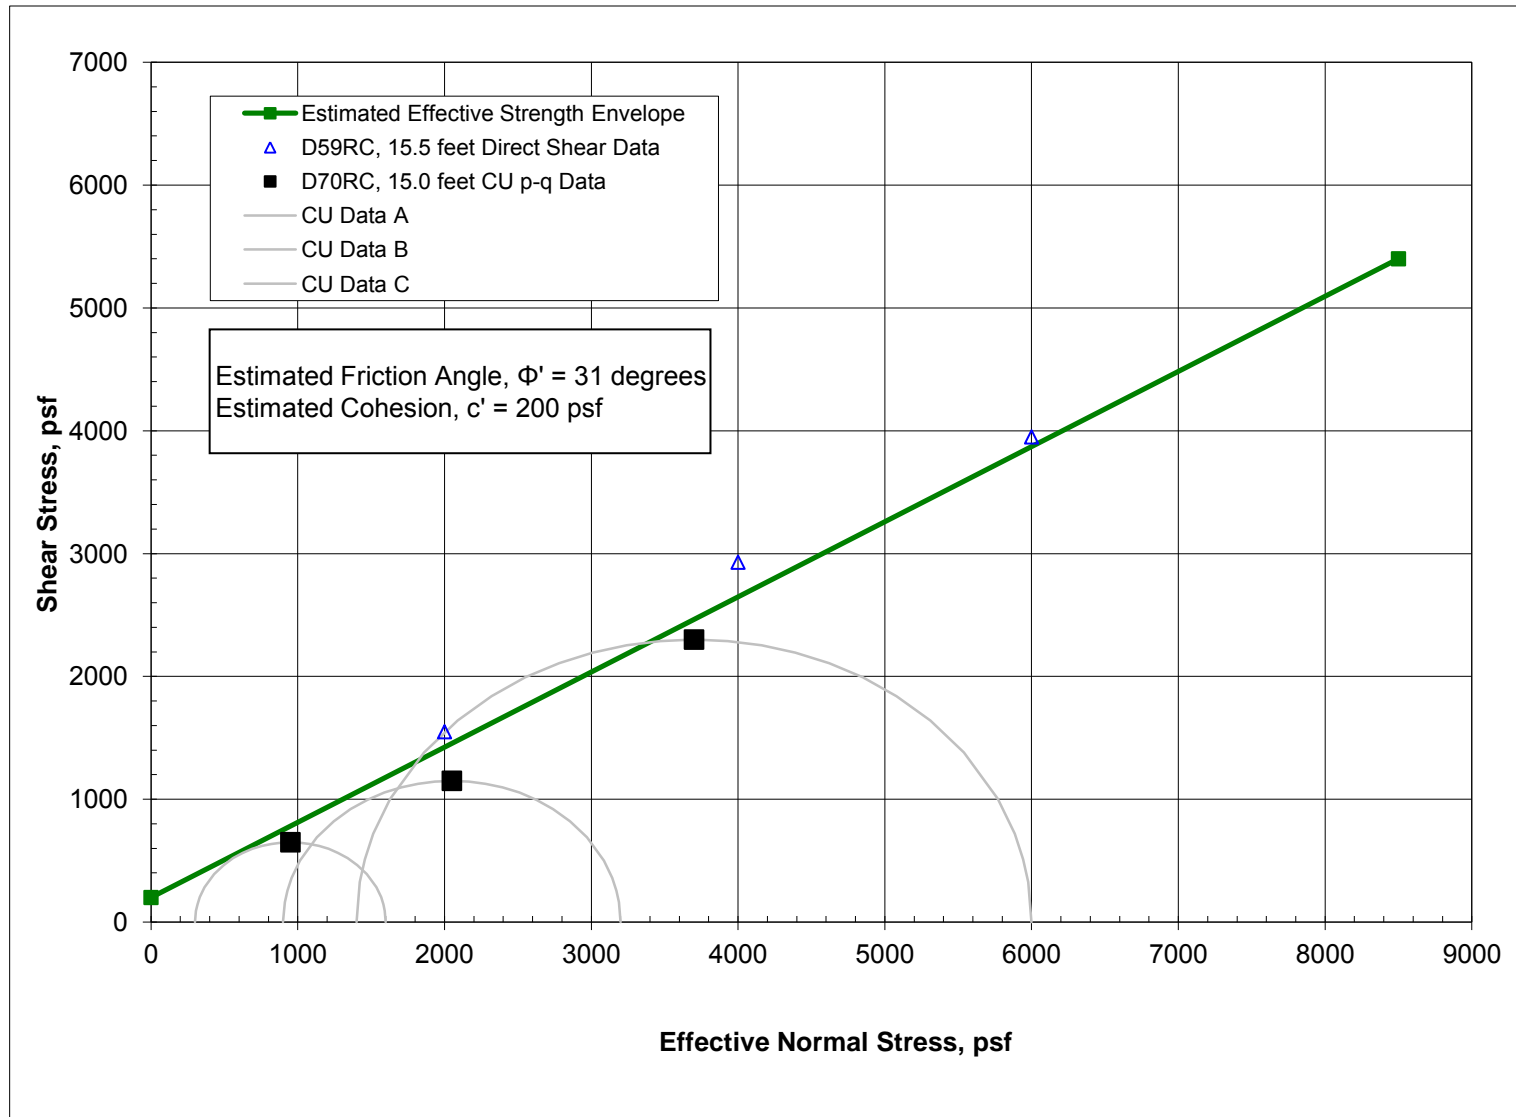
Effective Shear Strength Plot for Impervious Foundation Material

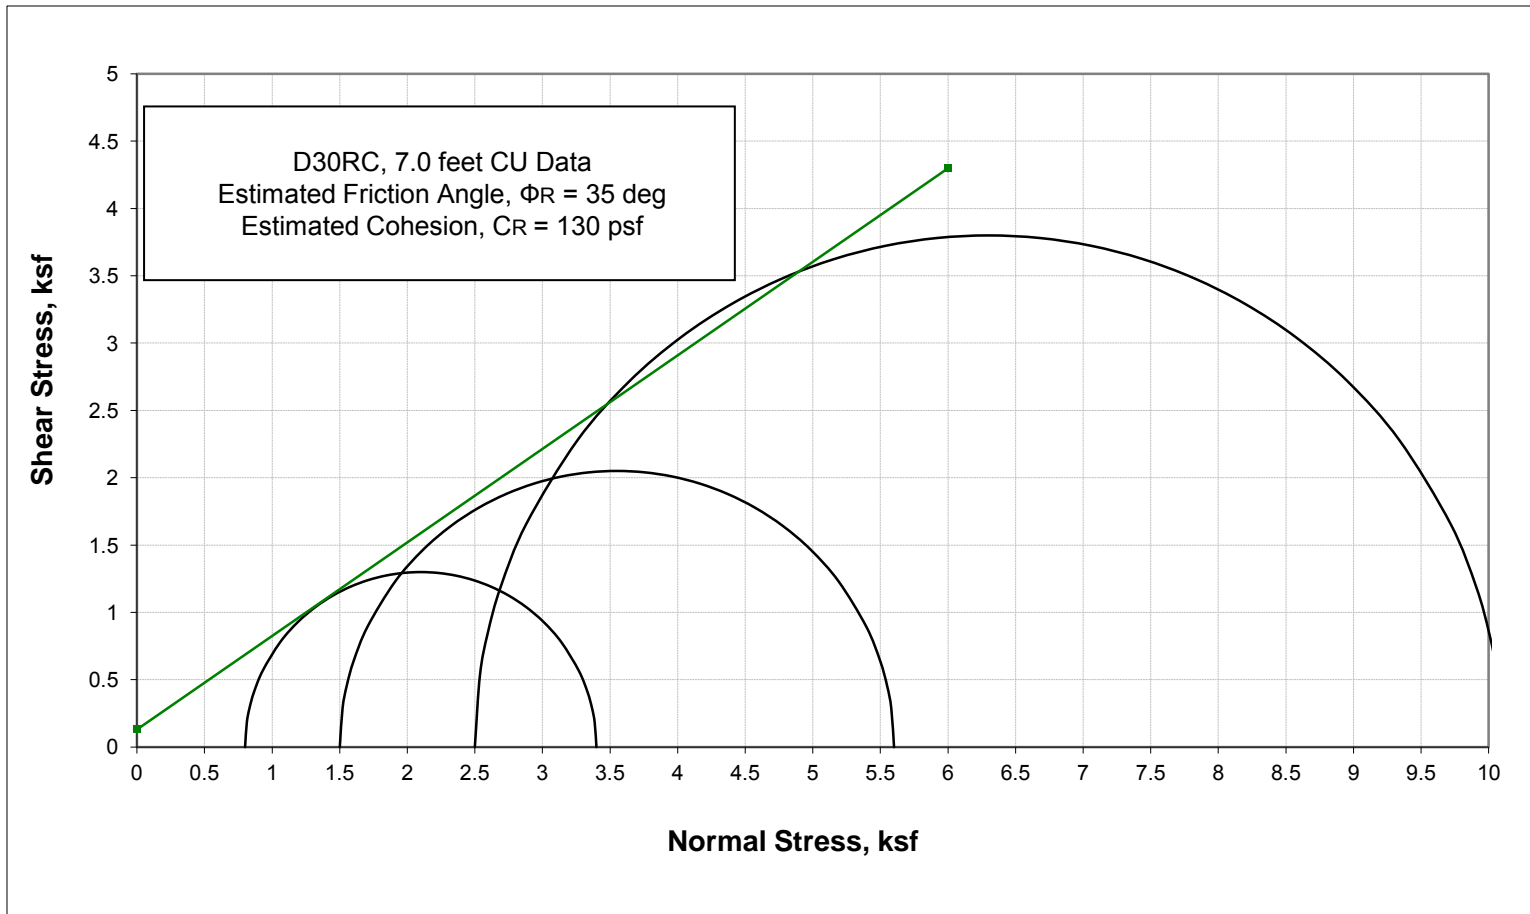
R Shear Strength Envelope Plot for Impervious Fill Material

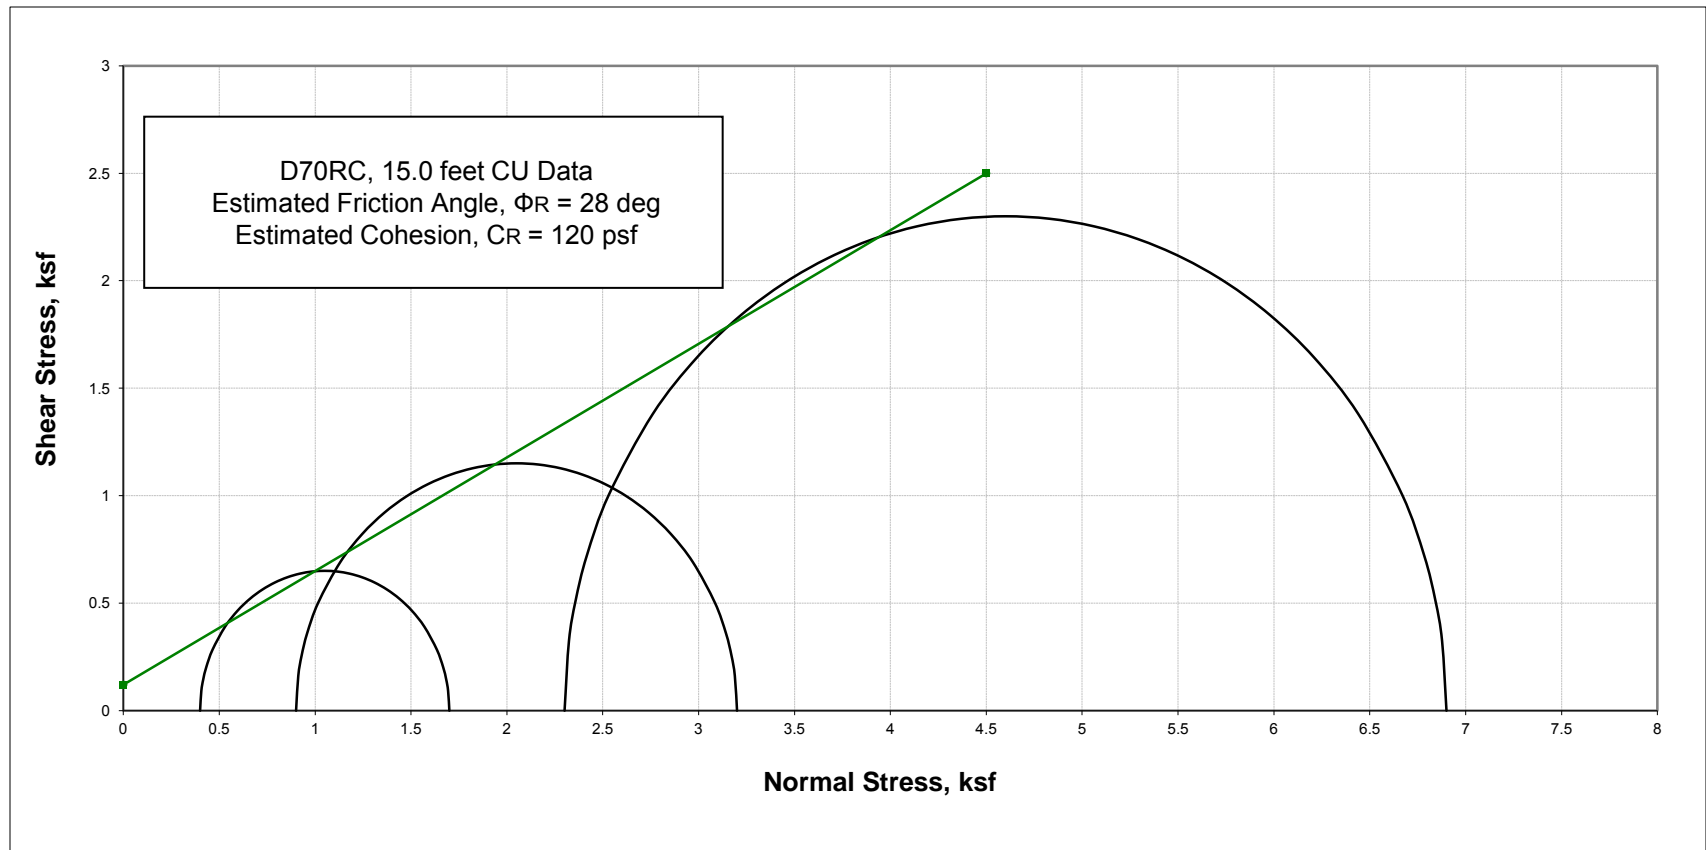
R Shear Strength Envelope Plot for Impervious Foundation Material

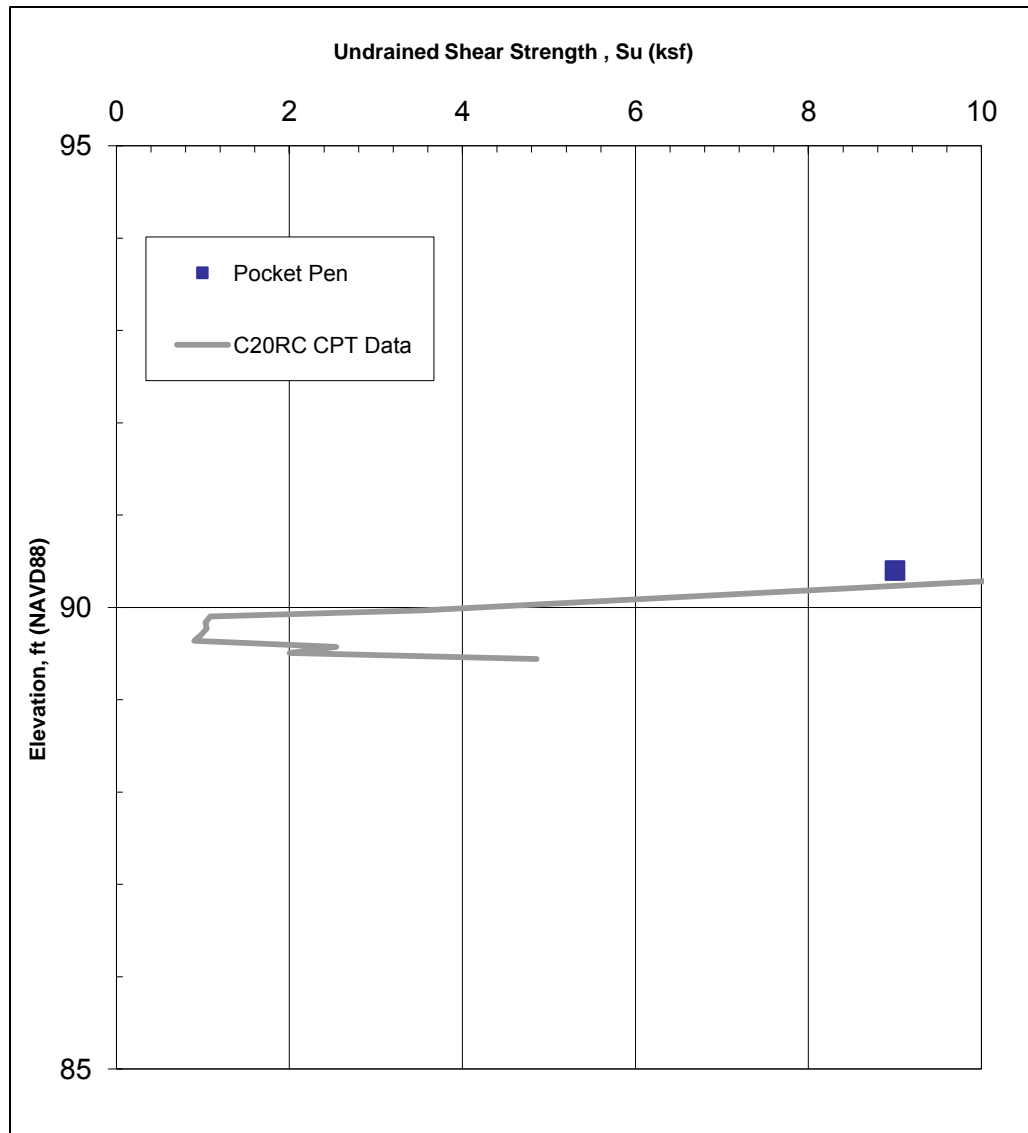
Undrained Shear Strength versus Elevation for Impervious Fill Material

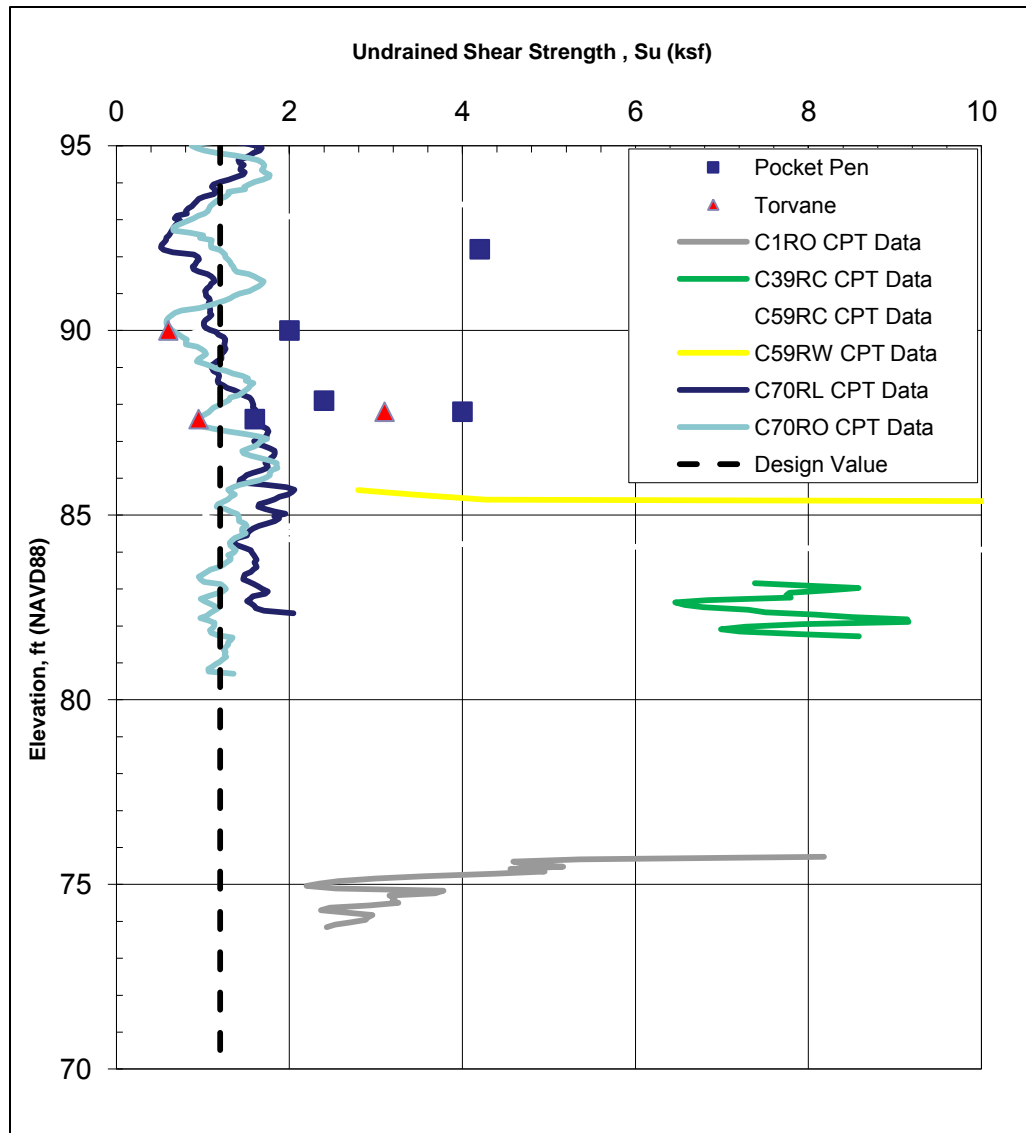
Undrained Shear Strength versus Elevation for Impervious Foundation Material
